# Crash Test Between a 6-KG/M U-Channel Sign Support and a 1997 Geo Metro: FOIL Test Number 99F010

PUBLICATION NO. FHWA-RD-01-046

MARCH 2001

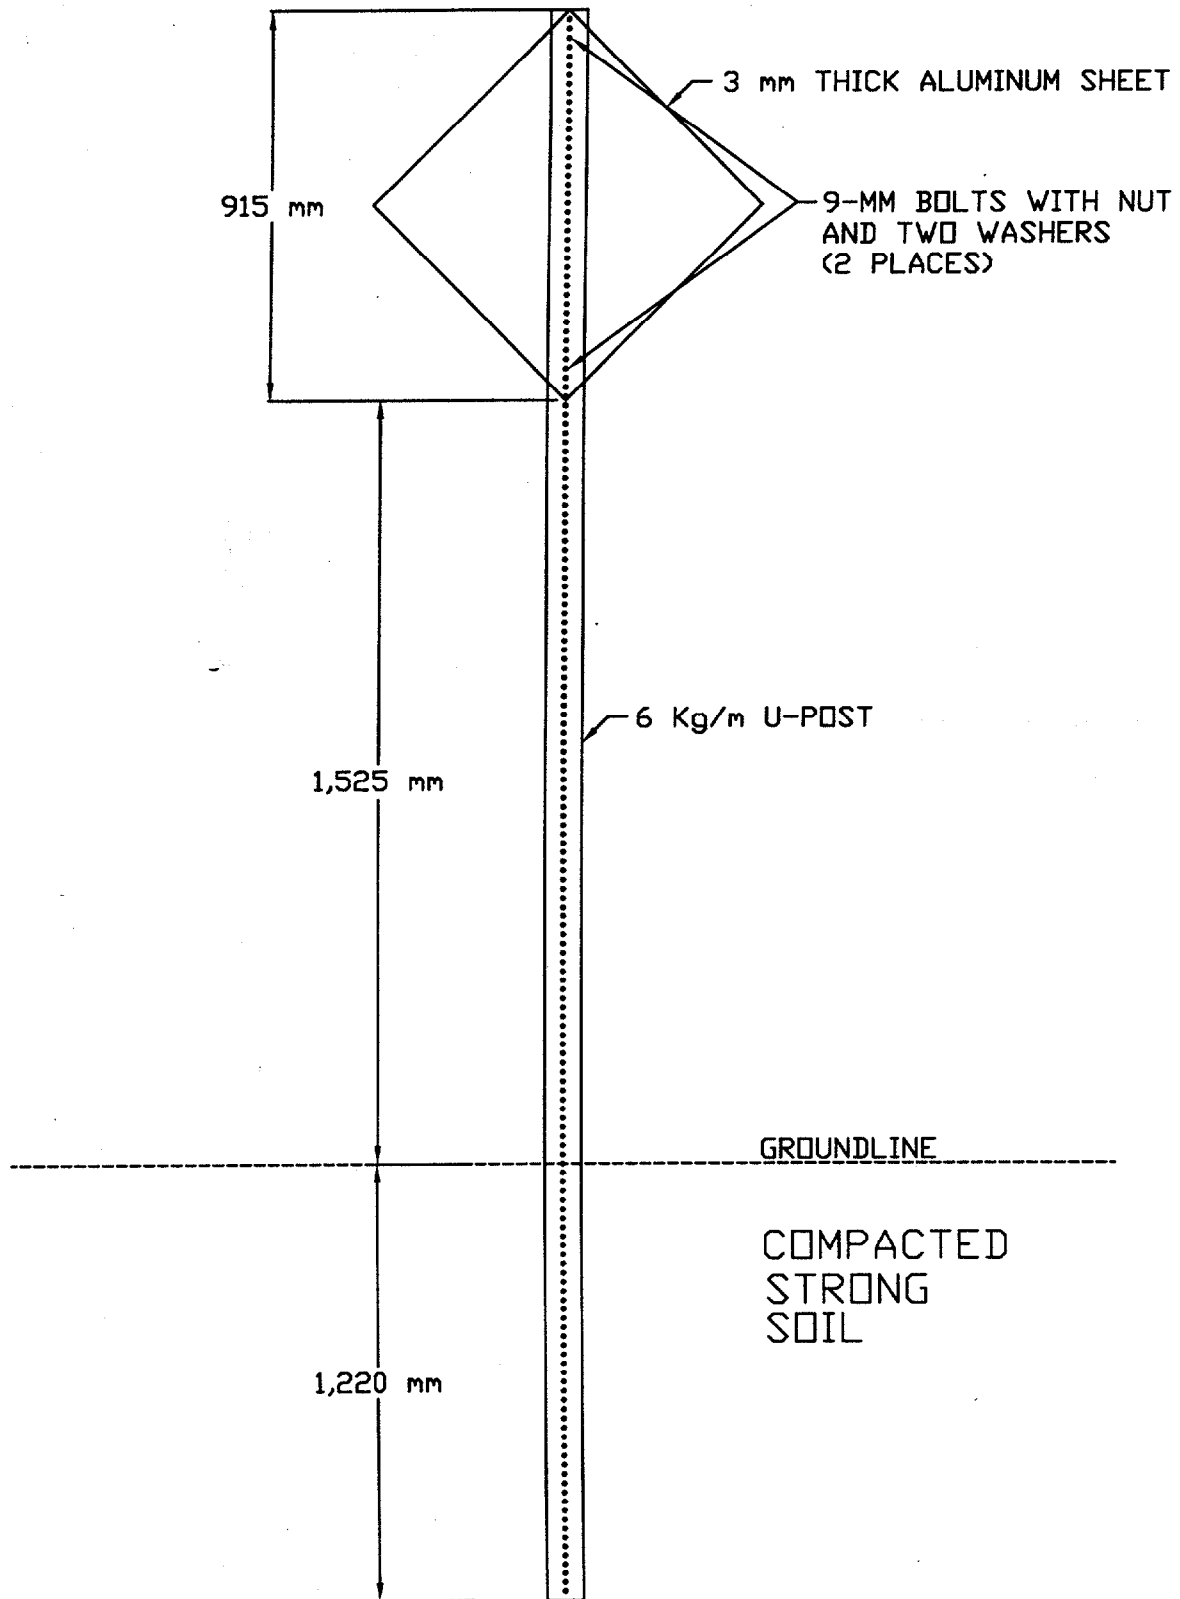
Figure 2. Sketch of small sign support.

Figure 2 illustrates the sign support installation. Refer to figures 7 and 8 in Appendix A for photographs of the test installation. Appendix C contains a stress-strain curve for the sign post material. The material testing was performed on specimens taken from the actual sign post tested. The material testing was conducted by the NCAC.
